# Kortlagning hættulegra staða, hindranir og ótti hjólreiðamanna á höfuðborgarsvæðinu

Beyond accidents: mapping hazards, disincentives and fear for cyclists in Iceland's Capital Area

Date of publication: 7th of April 2017

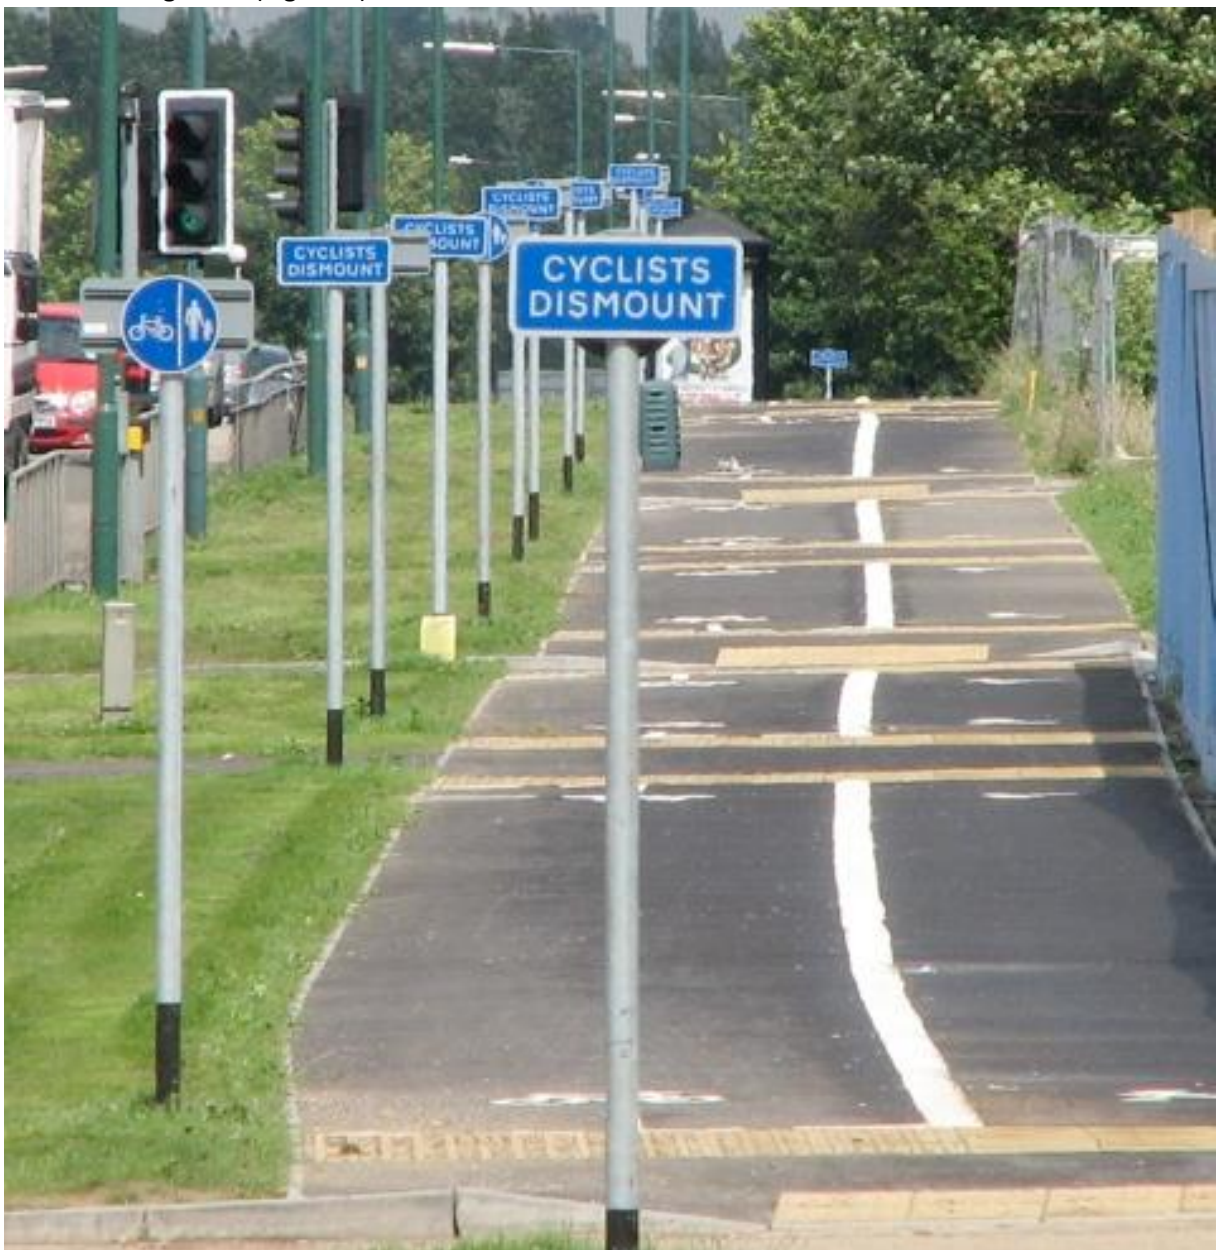
Figure 4 - Speed maintenance is a good thing. (UK street, from StackExchange)

2. **Smoothness.** More so than for cars, cycle lanes must be smooth, although not to the point of being dangerous in rain or ice. Drains and potholes can be fatal for cyclists, and cause significant damage to bikes, and the lack of suspension on most bicycles means that rough roads are a significant disincentive.
3. **Speed maintenance.** For cycling to be efficient and therefore attractive, it must be continuous. Braking and building up momentum again are more difficult for cyclists than other road users, and street design that requires dismounting is a significant inconvenience that is often ignored (Figure 4).

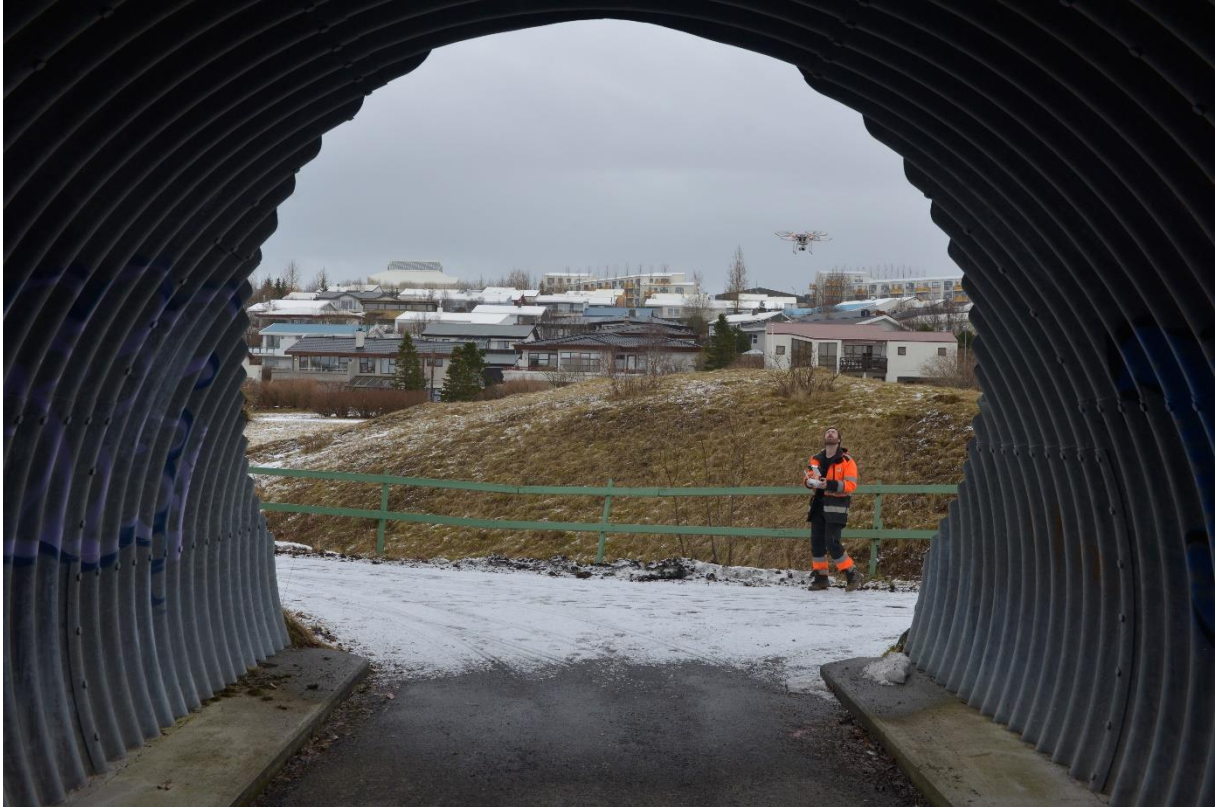
Figure 7 - Example of blind corner underpass with ReSource drone and operator. This one (on Dalvegur) has no change in elevation. (ReSource)

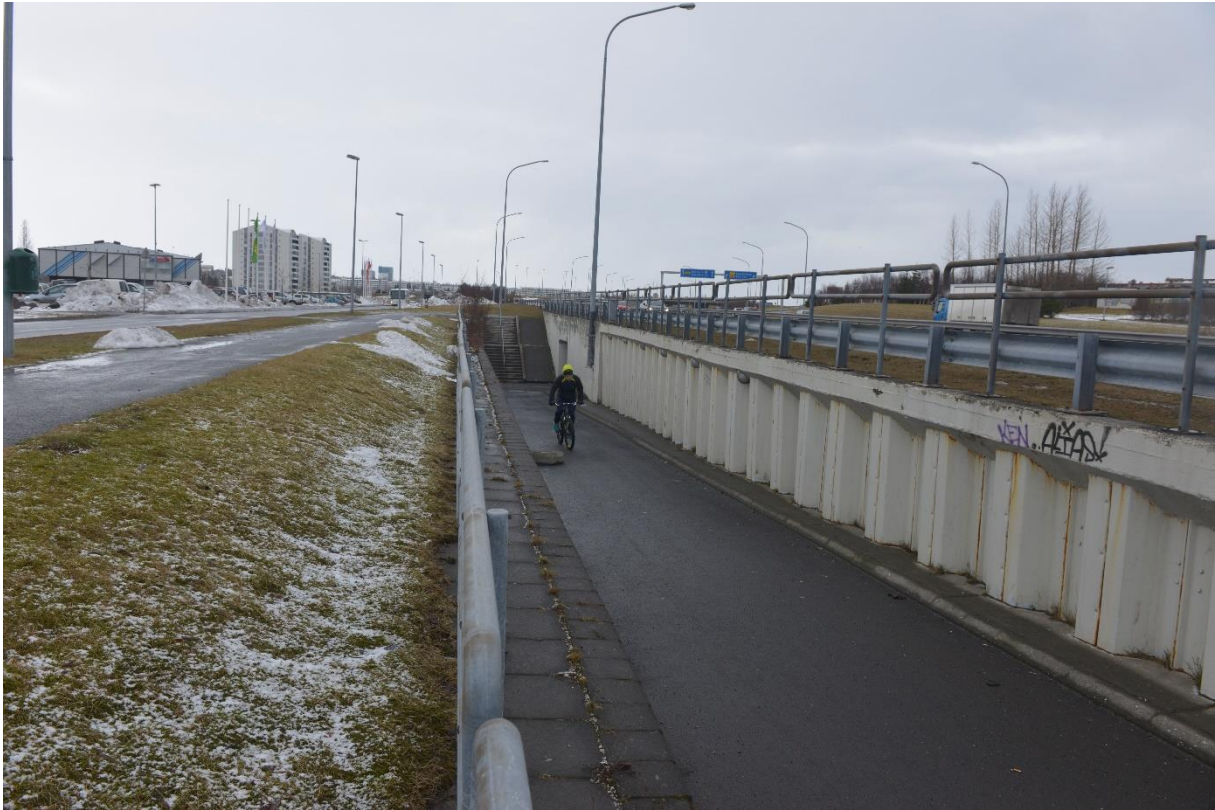
Figure 8 - Blind corner underpass at Mjódd, with long downhill slope encouraging acceleration and requiring braking (ReSource)

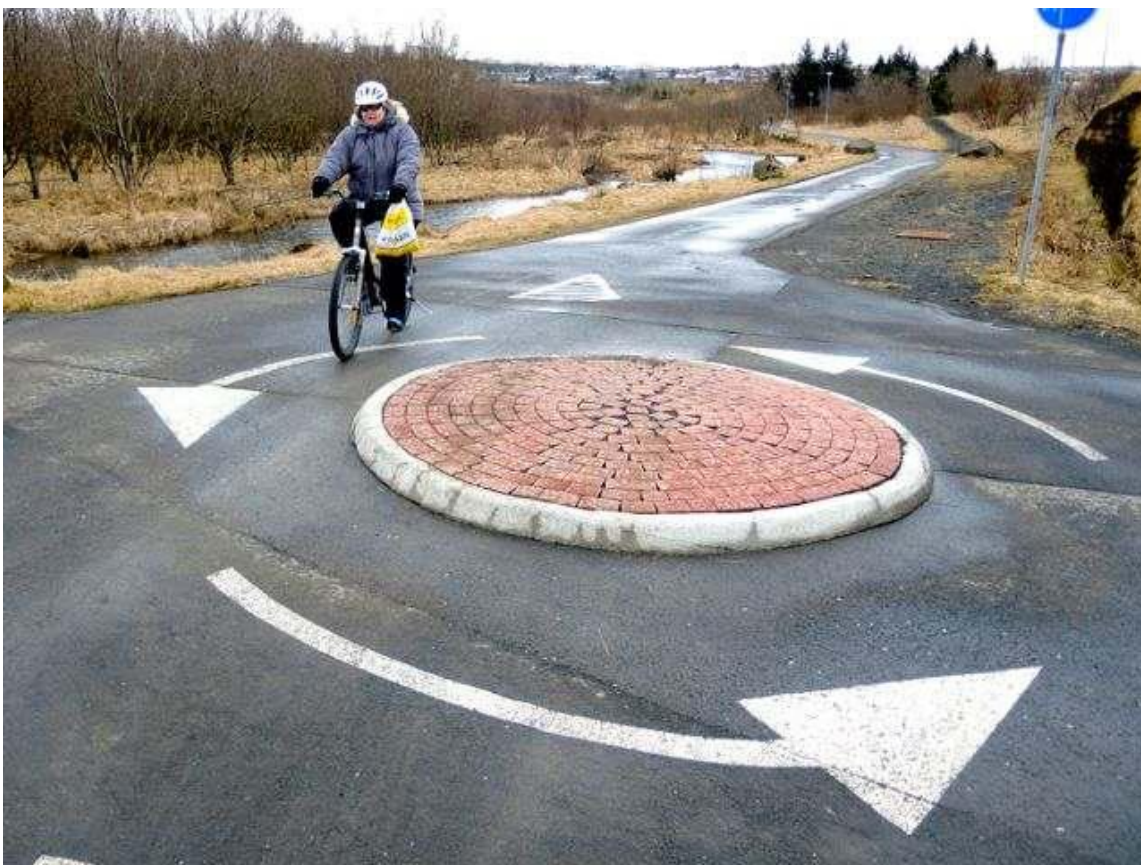
Figure 9 - Cycling roundabout, since removed, in the capital area (<http://sett.com/vagablondviews/reasons-6-10>).

In a few places, mini “roundabouts” have been constructed to try to alleviate the problem of uncertain traffic priorities on leaving underpasses. These tend to be where sightlines are good and force the slowing of cyclists and create another barrier to avoid. Painted priority marks on the road would be equally effective in persuading cyclists coming from the right in Figure 9 to give way to cyclists on the main path – however, this roundabout has been removed since this picture was taken, perhaps because of the hazard it created

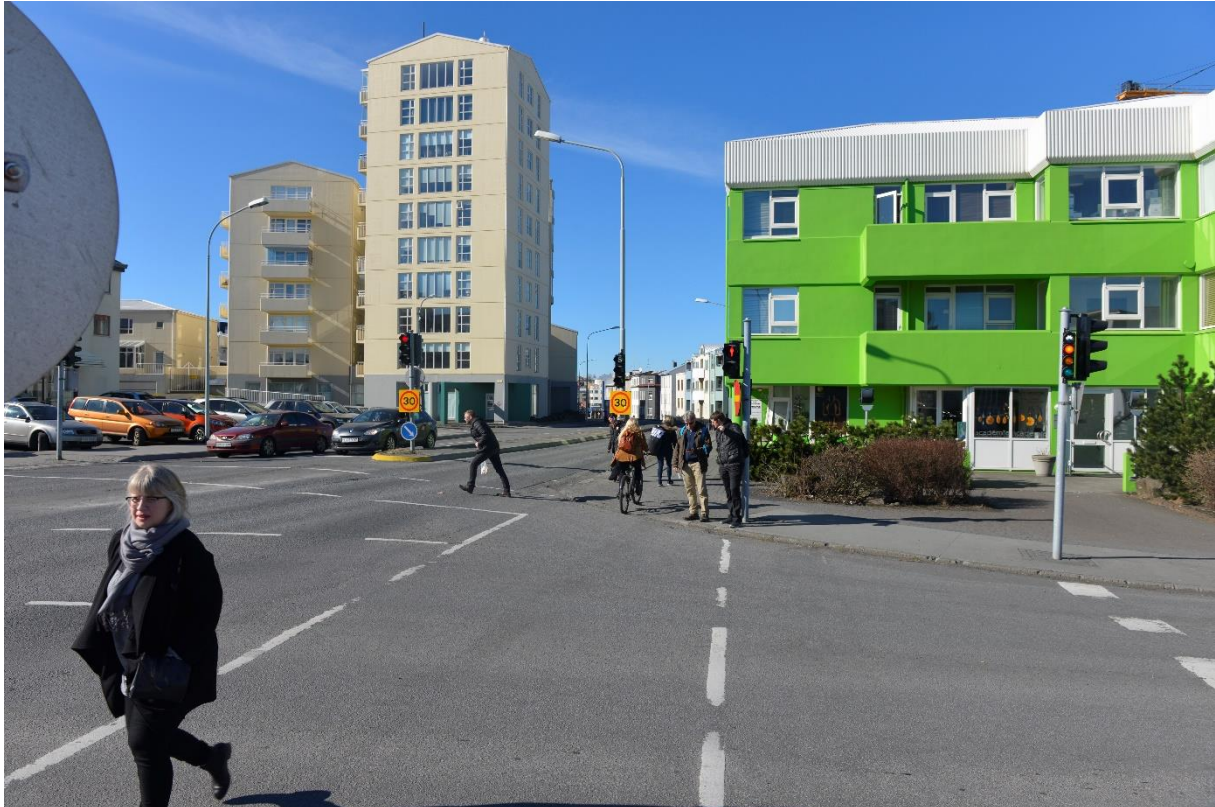
Figure 10 – The beginning of the approach to Hlemmur. Note cycle traffic lights on the right despite the lack of an onward cycle path, and the cyclist weaving between waiting pedestrians. (ReSource)

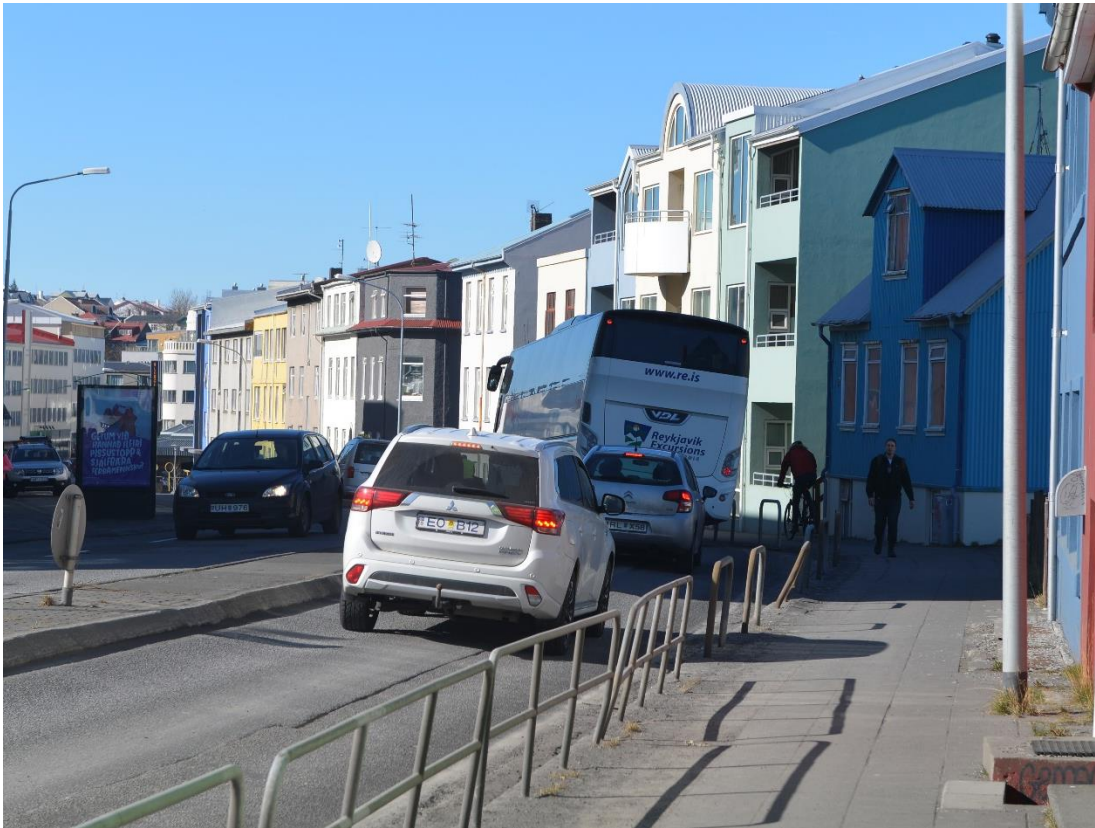
*Figure 11 – The approach to Hlemmur from the East. During a few minutes, five cyclists passed here, all on the narrow pavement. (ReSource)*

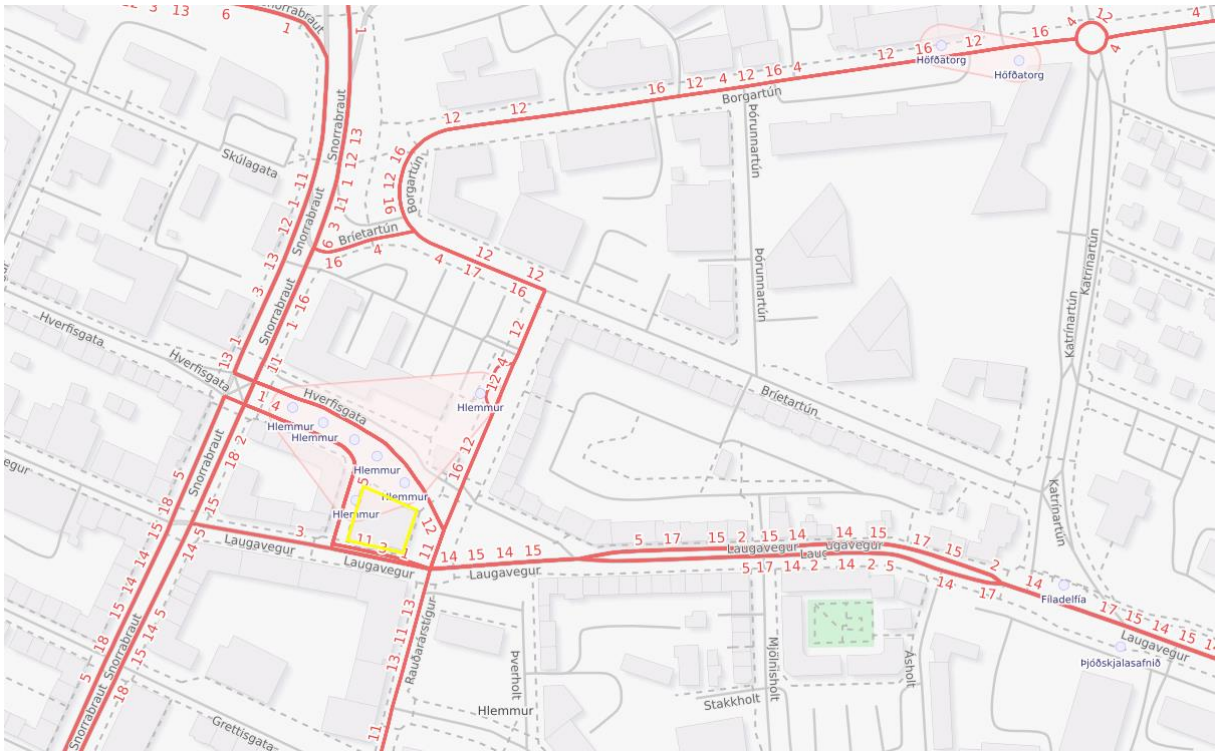
Figure 12 - Bus routes around Hlemmur (Openstreetmap)

More directly around Hlemmur, from the West cyclists must pass Hlemmur by either cycling on a narrow pavement up Laugavegur, cycling through a dangerous “bus only” street in front of the central Police station, or take a long detour around the back of this building, which loses elevation. From the East, the situation is a little better, but there is still a lack of connectivity with the new bike lanes on Hverfisgata and there are dangerous intersections. If cyclists approach these lanes from the South, they must go to the turn lane in the middle of Snorrabraut, a busy four-lane divided road. Traffic flow seems to be the main barrier to resolving these issues around Hlemmur, but this can be easily resolved.

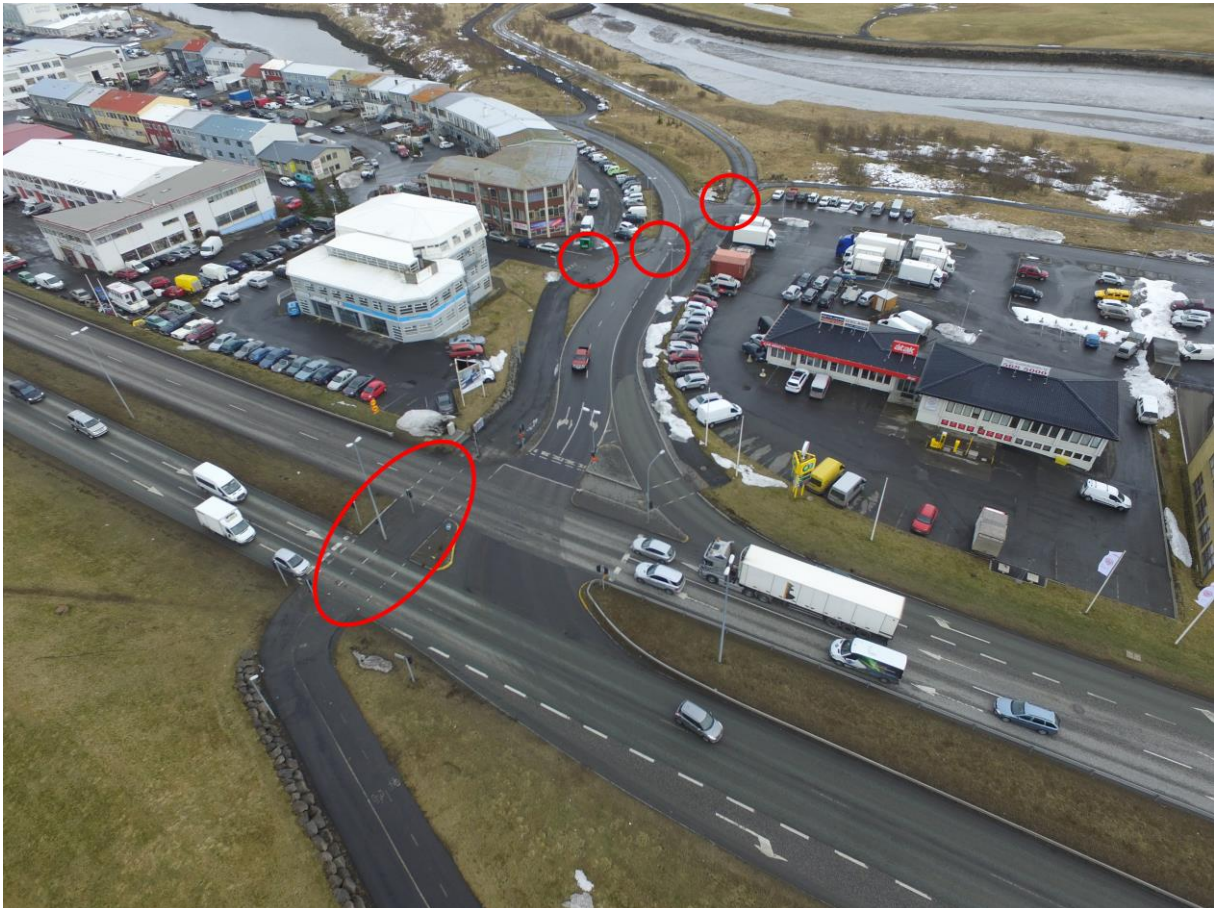
Figure 15 - Cycling junction at Sæbraut. Four road crossings can be seen. (ReSource)

Here, there are four junctions in the space of less than 100m, three of which are dangerous. From the West, the first (seen in Figure 15) is controlled by traffic lights and is unproblematic for safety, though

it does not have an independent control for bikes or pedestrians and wait times are often long. There, the bike lane goes steeply downhill and crosses a side street with priority, crosses Suðarvogur at a right-hand turn with priority to cars, and then crosses another side street with priority to the bike lane. On Knarrarvogur cars are unprepared for cyclists to be coming from the East, and on both cycling-priority junctions cars must straddle the bike lane before turning. It is far from ideal to have such similar constructions for different vehicle priorities in a whole city, never mind within a few meters of each other. In addition, cyclists from the parkland in the East are suddenly thrust into busy roads, which can be disorientating and something that car drivers on Knarrarvogur do not look for. Lastly, the whole junction takes considerable time to navigate at slow speeds.

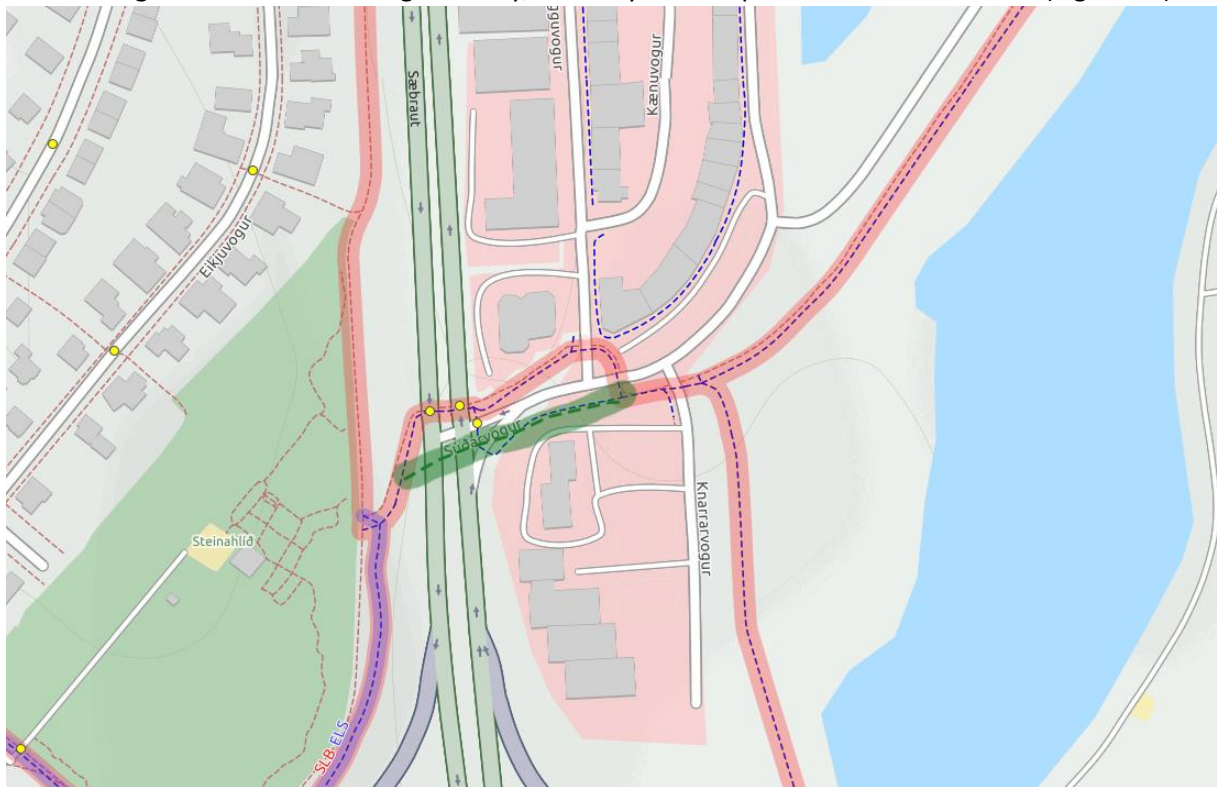
Figure 16 - Map of current bike lane situation (blue and red) at the west side of Elliðaárdalur, and proposed modification (green). (Openstreetmap)

There is a relatively easy way to improve the junction here – to move the crossing to the South side of Suðarvogur avoids two crossings entirely, and may even improve vehicle traffic flow (Figure 16).

Car traffic out of Suðarvogur to Sæbraut could thus turn right without a signal. The crossing of Sæbraut should also span the right-turn lane into Suðarvogur. The crossing of Suðarvogur should remain in order to provide access to the North for cyclists, but this would now be a low-traffic crossing.

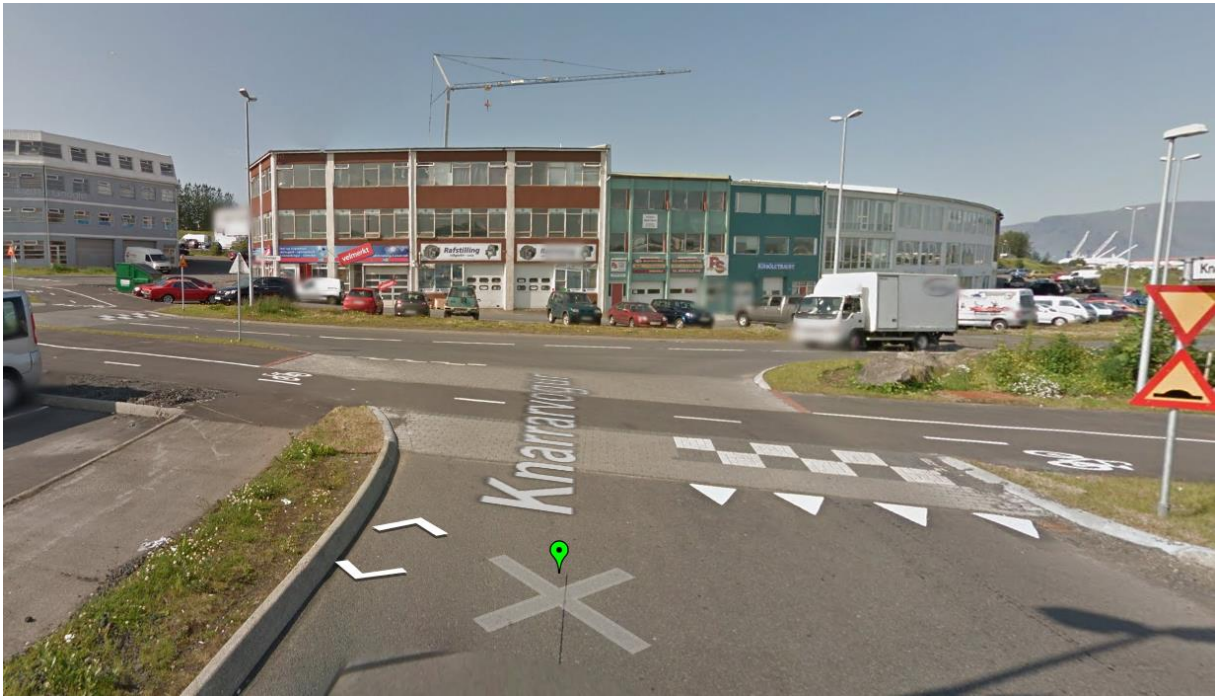
Figure 17 - Knarravogur crossing currently. Improved by a stop sign and on both sides a warning about bicycles crossing. The bike lane could also be or paved in red asphalt. (Google Streetview)

Additionally, at Knarrarvogur, extra precautions should be made for cars coming onto and from Suðarvogur. The intersection is currently raised, but as this is a parking lot with good exit visibility, it is quite possible to have a stop sign for cars before the cycle crossing in addition to signs about bicycles on both sides. Visibility could be improved further through the use of coloured red asphalt to pave the bike lane – this is common in the Netherlands and Denmark, and unlike road paint is totally impervious to studded tyre wear and poses no slipping hazard for cyclists. In general, it is good (and current practice in most places in the Netherlands) to make crossings of roads cycle-priority, except where there are lights – in other words, the same system that currently exists for pedestrians.

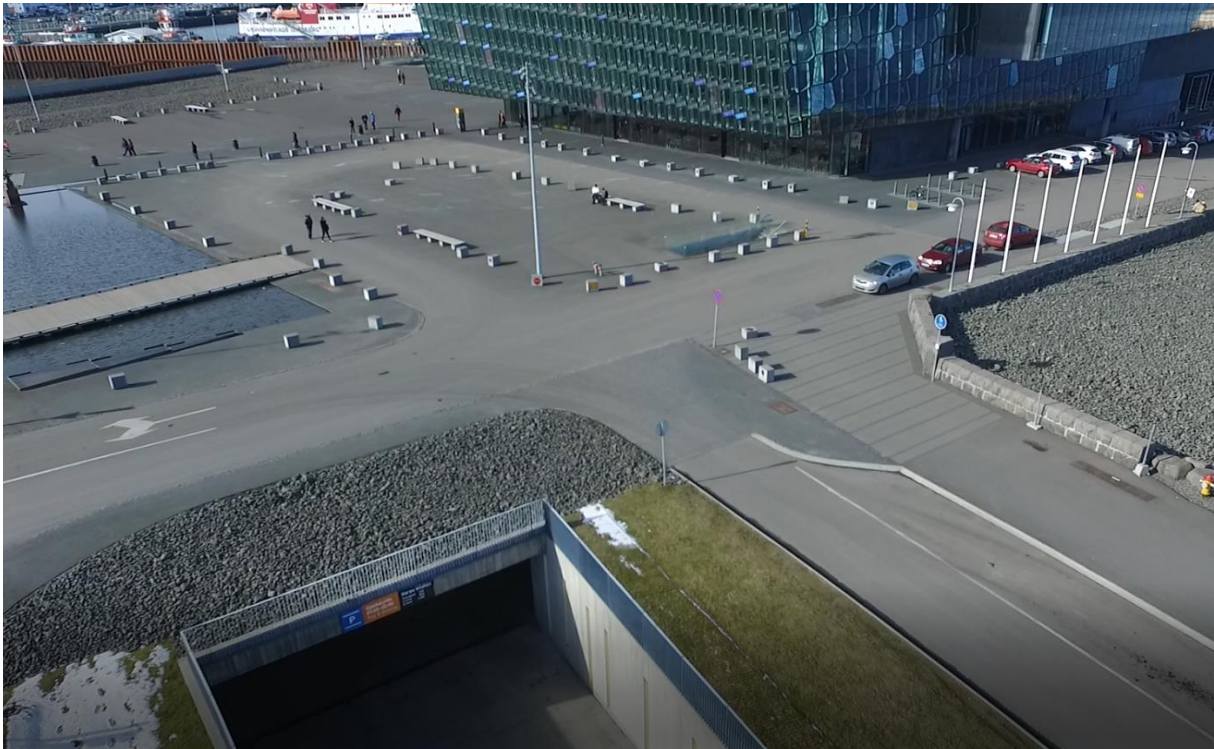
Figure 18 - Elevation from front of Harpa. Note concrete bollards, lack of marking, poor-visibility glass and badly-indicated water trench (ReSource)

The best example of this is outside the front of Harpa, which cyclists might be forgiven for thinking had been designed as an obstacle course. The main seafront cycle path from East to West is unmarked on a busy pavement on the approach to Harpa where many tourists are moving unpredictably. It then passes through a busy pedestrian square outside the front of Harpa, which is surrounded by concrete blocks and often has bus traffic. Near the East end of this, there is a glass fence around a stairwell that is difficult to see at night or in some lights. The most dangerous of all is an unmarked water trench that bisects the bicycle path with a narrow, slippery metal bridge across it. In order to stop cyclists falling into the trench, concrete blocks have been arranged in front of it, but if there are pedestrians crossing the bridge then cyclists may attempt to pass between the blocks to avoid them.

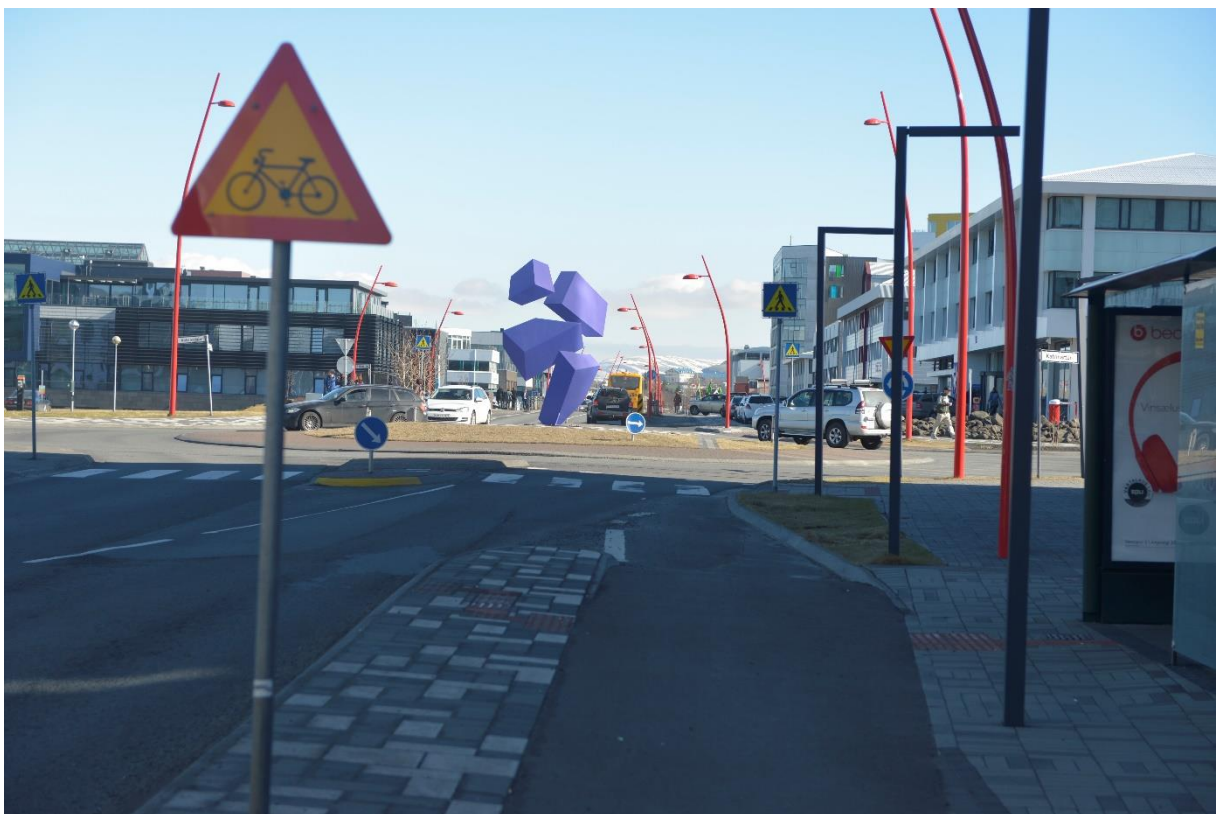
Figure 24 - Entry to roundabout on Borgartún. Attractive, but dangerous. (ReSource)

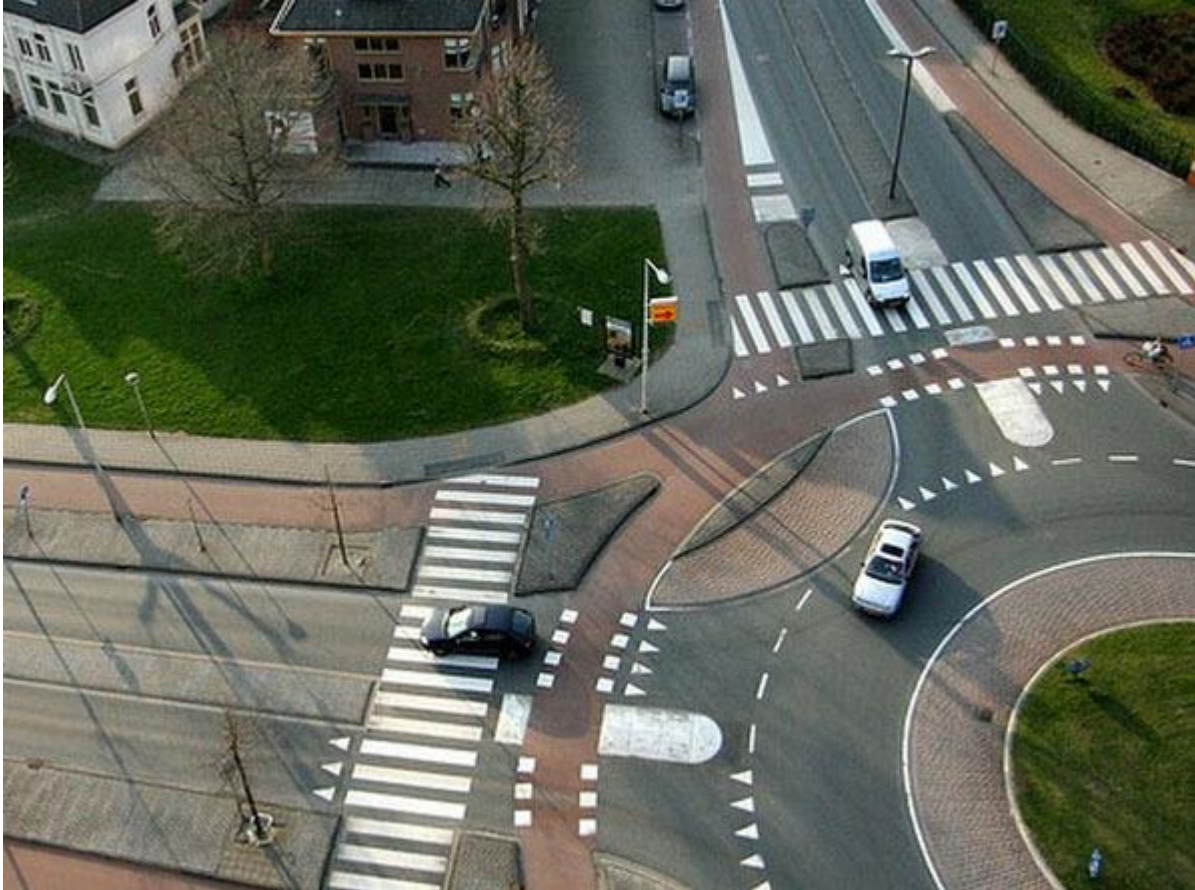
Figure 26 - Example of a convenient but dangerous design for cyclists, again from the Netherlands (source unknown). Lack of cycle awareness in Iceland is likely to make this design more dangerous.

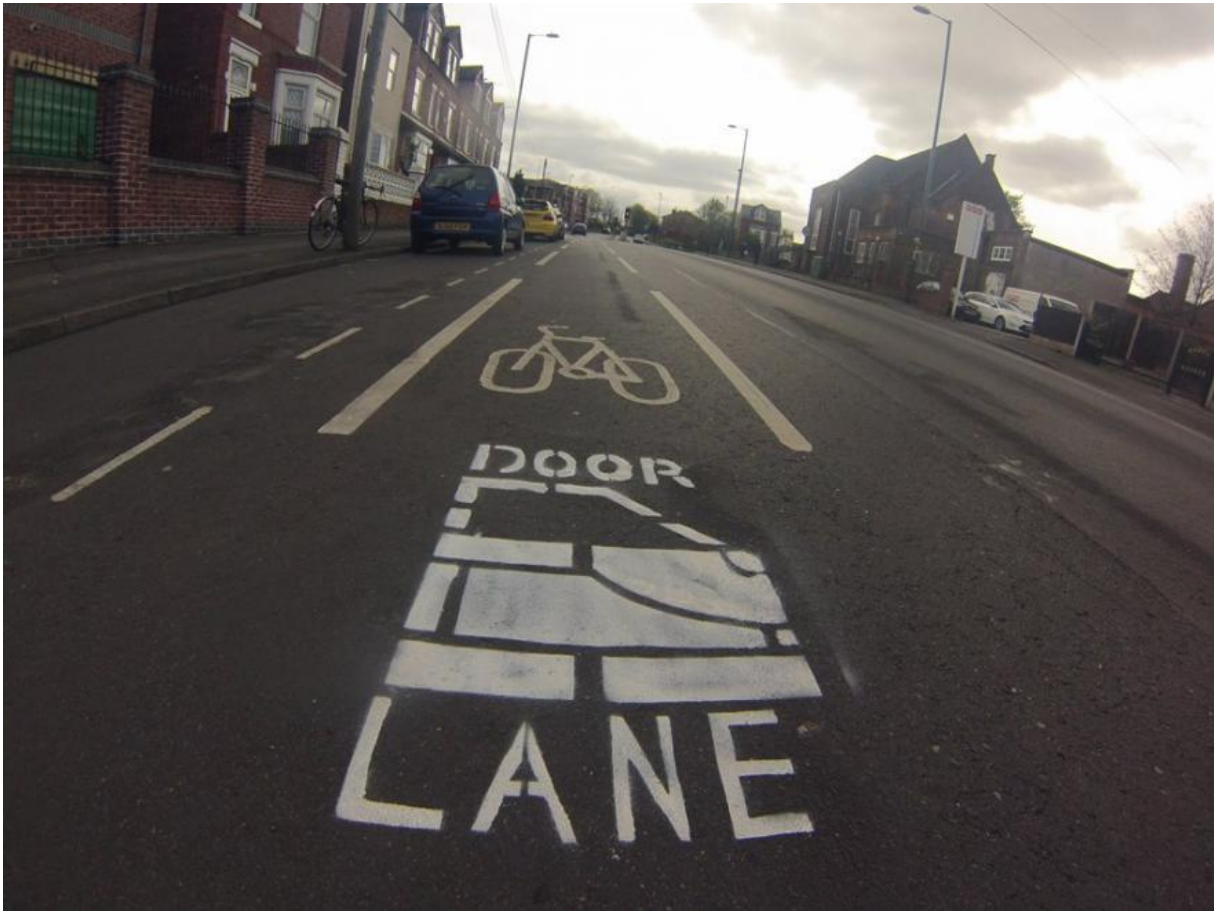
Figure 27 - Cyclists' graffiti in Nottingham, UK. The cyclists on this bike lane are at risk from the doors of drivers of cars. (road.cc)

In particular, one item was noticeably absent - so-called “dooring”, where a parked car driver opens their door onto a cyclist (Figure 27). There is only one note for this in the whole city – in the middle of Reykjavík on Lækjargata where it caused a broken elbow – whereas it is relatively common in other cities. This may be partly a result of the tendency of cyclists to cycle on the pavement when not on quiet streets, but also indicates that cyclists are not put at great risk by badly-designed bike lanes, such as is common in the USA and UK. Instead, most of the capital area’s bike lanes (where they exist) appear to follow the Dutch model of protecting lanes where possible, and shared streets are marked with “sharrows” on the road instead of trying to separate cyclists and vehicles in a strict pattern.
